# Manhole Inspection Summary

Manhole # S19II\_007MH

Insp Date: **6/21/07 11:44 AM**

**Location** Address: **2000 PRESBURY ST**

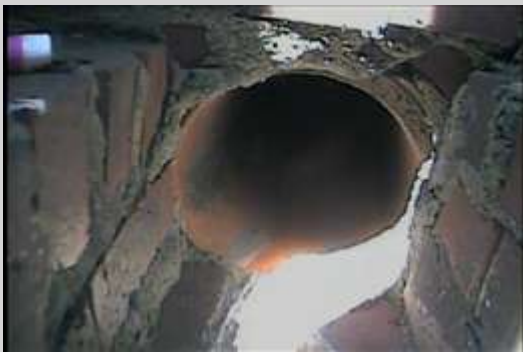
12 O'Clock Outflow

8 in. Circular Gravity Sewer  
Pipe Out @ 12 O'Clock

Pipe Height: **8.4** (in.) Rod and Bar (Angled)  
Pipe Material: **Clay** ☐ Pipe Lined  
Invert Depth: **6.69** (ft.) Flow Characteristics: **Slow**  
Deposits: ☒ None ☐ Mud ☐ Sludge ☐ **Debris** ☐ Grease  
Silt Depth: (in.) Deposits Extent:  
Infiltration: **None** Pipe Seal Cond: **Sound**

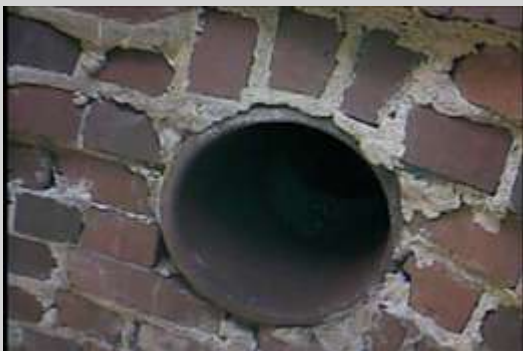
3 O'Clock Inflow

8 in. Circular Gravity Sewer  
Pipe In @ 3 O'Clock

Pipe Height: **8.4** (in.) Rod and Bar (Angled)  
Pipe Material: **Clay** ☐ Pipe Lined  
Invert Depth: **3.60** (ft.) Flow Characteristics: **Slow**  
Deposits: ☒ None ☐ Mud ☐ Sludge ☐ **Debris** ☐ Grease  
Silt Depth: (in.) Deposits Extent:  
Infiltration: **None** Pipe Seal Cond: **Sound**

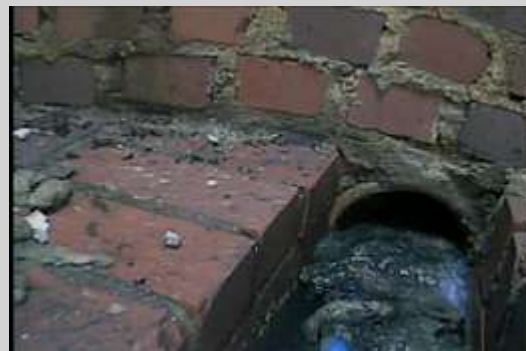
Drop In @ 3 O'Clock

Drop: **Outside** Rod and Bar  
Angled: **Yes** Reading: **5.58** (ft.)  
Inv Depth: **6.58** (ft.)  
Drop Condition: **Open**

Connects To: **Connecting Node Not Available**
